**BLUE OAK ASSESSMENT  
DISC GOLF COURSE DESIGN REVIEW AND  
BLUE OAK MANAGEMENT GUIDELINES**

**Prepared for  
THE CITY OF CHICO**

**Prepared by  
TREE ASSOCIATES  
John M. Lichter, M.S.**

**November 18, 2005**

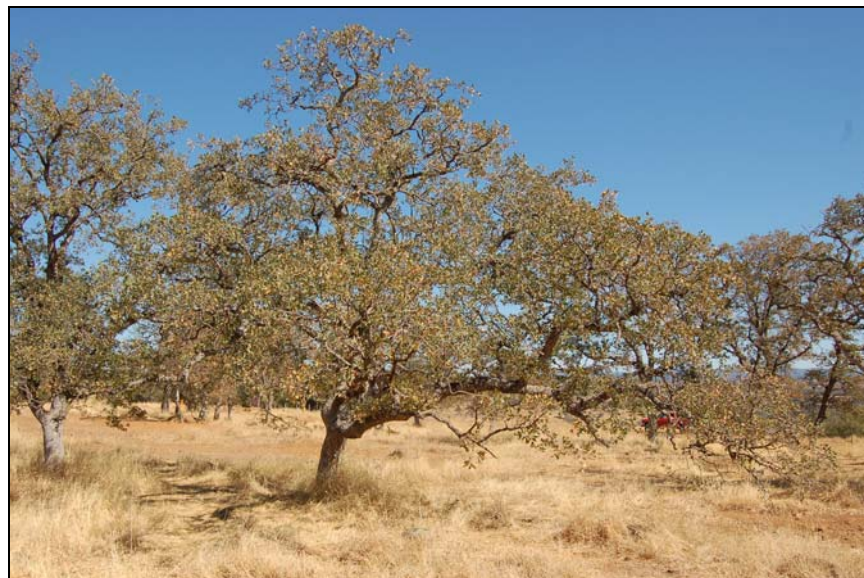
Figure 2. Tree in fair/good health on short course.

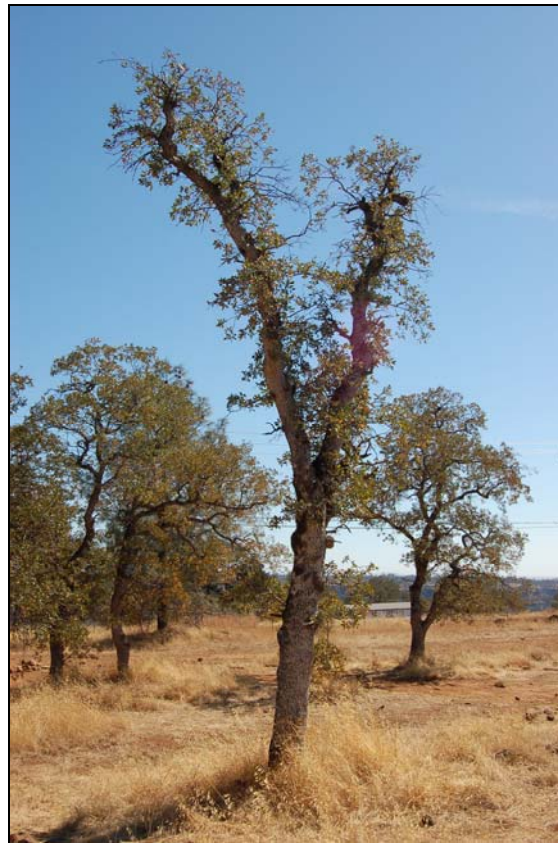
Figure 3. Tree in poor condition on short course; note poor growth rate and epicormic sprouts (low vigor twigs on main trunk).

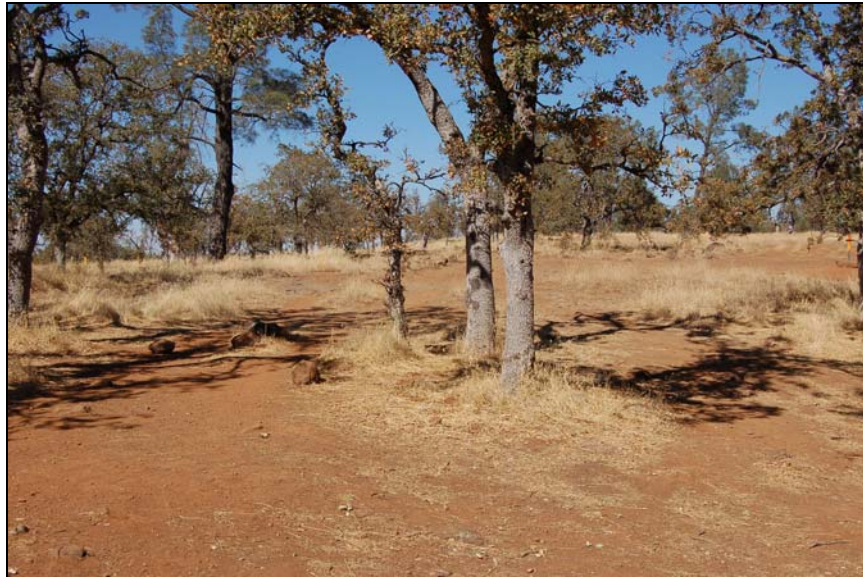
The loss of vegetation, organic matter and soil compaction was most pronounced at the tee and pin areas on both courses (figure 4). Within the short course, the fairways were heavily trampled throughout, while on the long course, only a few narrow trails were typically found on the fairways.

Soil compaction rearranges soil particles, increasing soil strength and reducing the amount of large pore space in the soil. These changes can restrict root growth directly, and lead to growth restriction and/or disease from their negative impact on soil water infiltration, drainage and aeration.

Figure 4. Soil disturbance under oaks on short course.

Because remediating compacted soils is difficult and not always effective, preventing soil compaction on as yet undisturbed treed portions of the proposed course is of prime importance. Preventing the re-compaction of ameliorated soil is also of obvious benefit.

Breaking up the soil (i.e. tilling or subsoiling) when it is fairly dry is an effective means of ameliorating compacted soils (Harris, R., N. Matheny and J. Clark, 2004). However, "tree root sensitive" treatments for breaking up soils in the root zone of trees are limited. Soil removal and replacement (with sandy loam, organic matter or combinations of soil and organic matter) in radially-oriented trenches has been shown to increase tree growth (Day and Bassuk, 1994; Watson, Kelsey, and Woodtli, 1996; and Smiley, 1997). The soil can also be broken up effectively with minimal damage to tree root systems utilizing a pneumatic excavator. Recently, soil compaction amelioration treatments utilizing a pneumatic excavator to break up the soil while incorporating organic matter have been recommended by Smiley (personal communication).

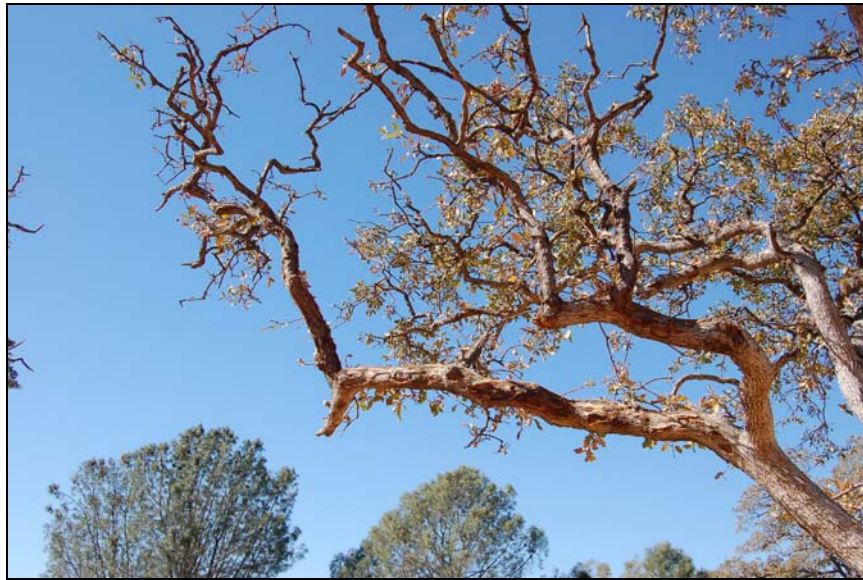
The loss of branch tips and foliage was widespread across the course, particularly where trees were in the middle of the fairway (figure 5). In several cases, greater than 50% of the foliage and branch tips had been removed by discs. The amount of foliage and branch tip loss was generally greater on the short course than for the long course.

Several trees across the course sustained significant damage to their cambium from disc contact; particularly trees close to tees (figure 5).

On a course wide basis, the damage to trunk and limbs is of lesser importance than the factors discussed above, as fewer trees are impacted and, for many of these trees, the impact is limited to a particular branch and/or one side of the trunk. However, this damage can have a significant impact on tree health, particularly for small trees and when foliage and branch tip damage occurs in addition, which is common.

Figure 5. Loss of foliage and growing points and limb damage from disc impact on short course.

For such affected trees, wrapping the trunk or limbs with protective material or shielding the impacted (or potentially impacted) trunk or limbs will limit impacts. Trunk or limb wrapping should be done in such a way as to avoid girdling (restricting diameter growth) the tree. Shielding should be done in such a way as to avoid root injury.
