# Interim (Adaptive) Wet Weather Management Plan

Prepared for  
The  
General Services Department  
City of Chico Parks and Open Space Division

Prepared by  
Chico Environmental  
Science and Planning

December, 2009

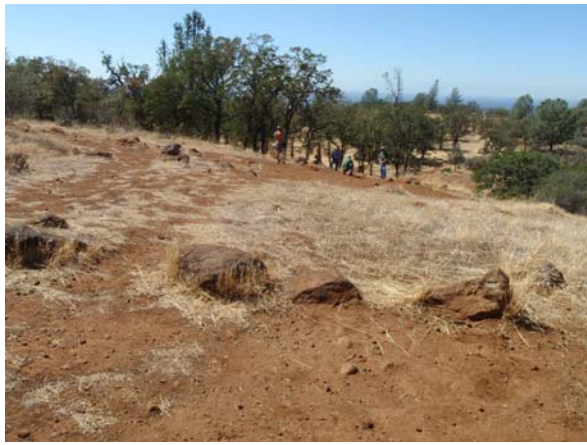
Reference point 1: Looking West from Tee 2.

*Vegetation is dry and has been trampled in some areas. Top soil has been eroded from lower portion of original tee area and in path towards target, more rocks visible than last inspection. Trail is .5 feet wider than last inspection. See reference points 2 and 3.*

*Move tee to flat upper area. Seed and cover bare dirt in original tee area.*

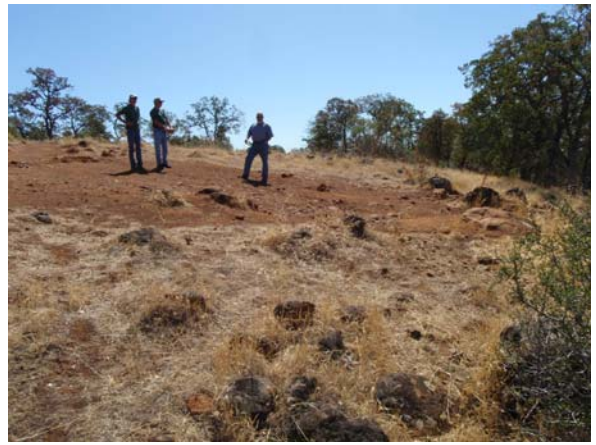
Reference point 2: Looking North from below Tee 2.

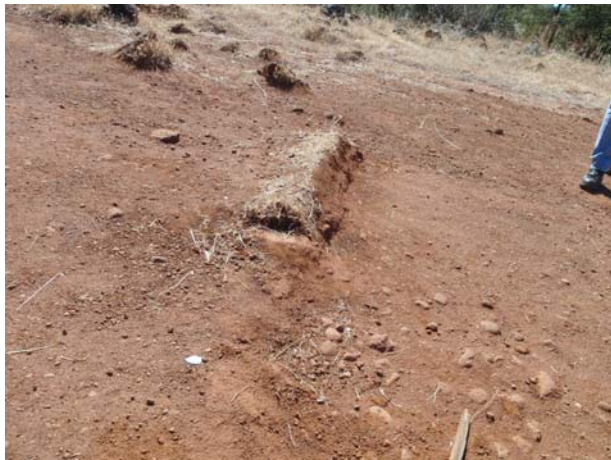
Reference point 3: Previous bench location at Tee 2.

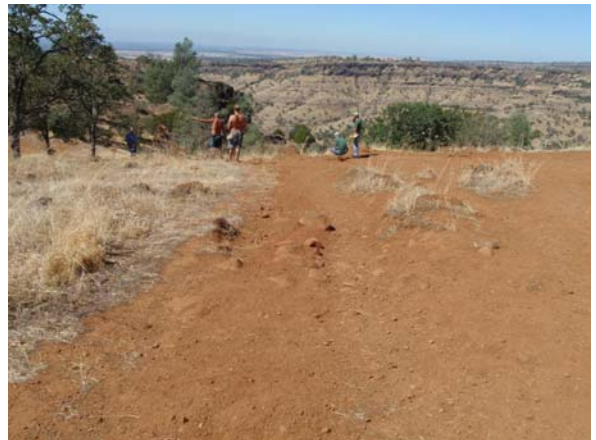
Photo 4: Path is eroding. More exposed rocks and less soil.

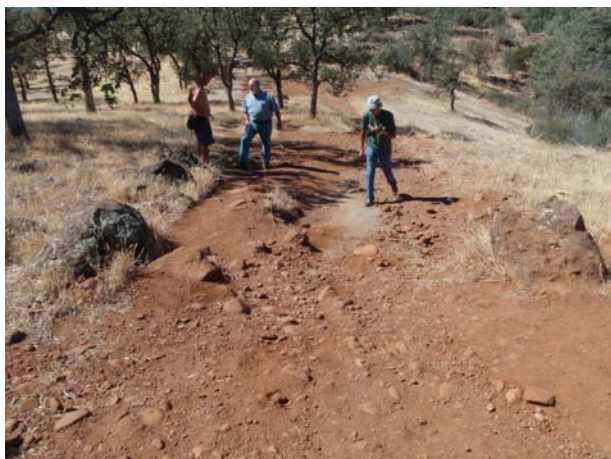
Photo 5: Additional erosion and mtn bike tracks.

*Bike tire marks in bare dirt area. Appear to be skids during dry weather.*

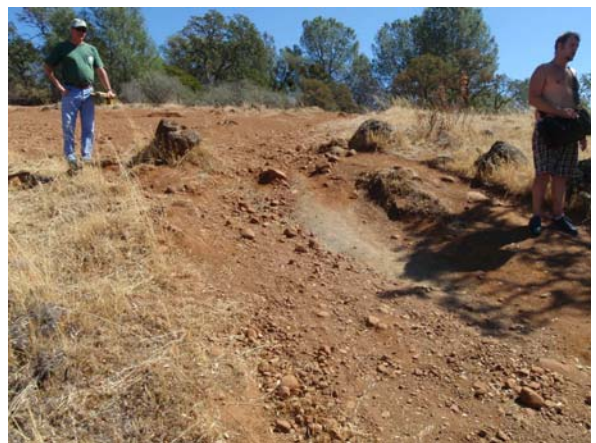
Photo 6: Deep rut with horse prints.
